Failure analysis of a hot extrusion die used for Al–Li alloy processing

U RAMA MURTY, G S AVADHANI and E S DWARAKADASA

Department of Metallurgy, Indian Institute of Science, Bangalore 560 012, India

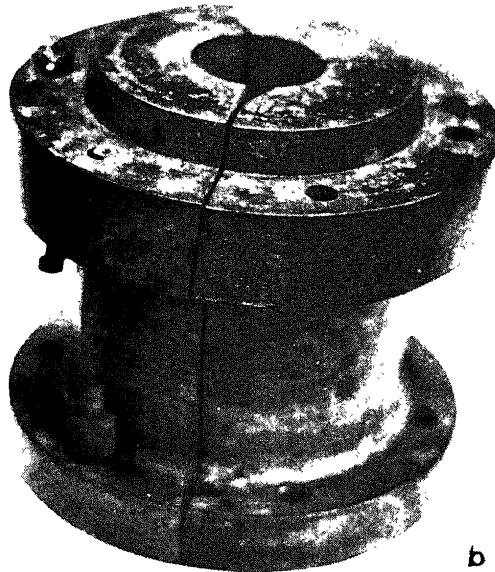
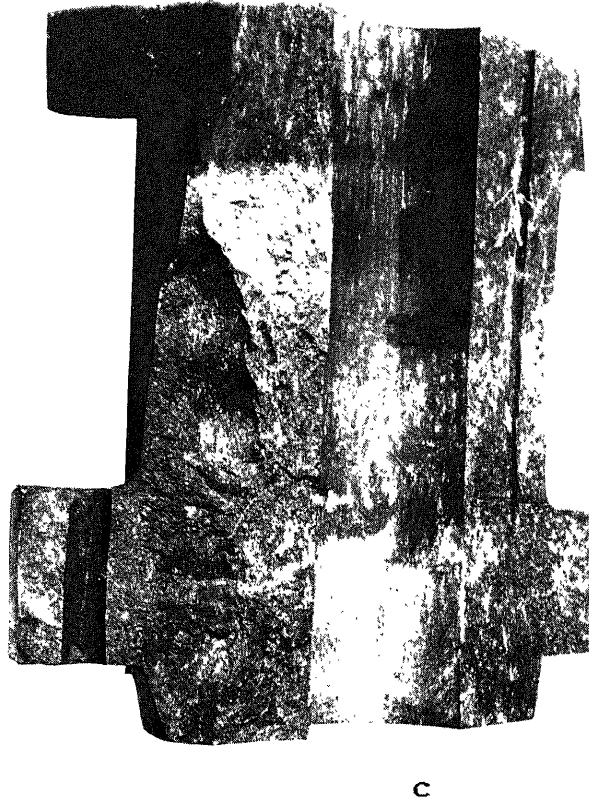
Figure 1. a. Cross-section of the die container (schematic), b. picture of the failed die container and c. fractured surfaces.

The die failed into three large fully fractured pieces (figure 1b) and several smaller fragments from areas close to the die lip. The major fracture surfaces (figure 1c) did not reveal any signs of brittleness or the presence of any prior cracked regions which might occur due to bad heat-treatment. The fracture surface was quite granular indicating a very ductile failure. The nature of failure indicated that the cracking initiated from the inner surface of the die and opened outwards. It is known that elemental Li reacts with carbides of iron and other elements, and can cause embrittlement; also during high temperature treatment of Al-Li alloys, there occurs Li diffusion to the surface and loss by sublimation. This prior knowledge prompted this investigation to determine if Li was responsible for the failure of the die.

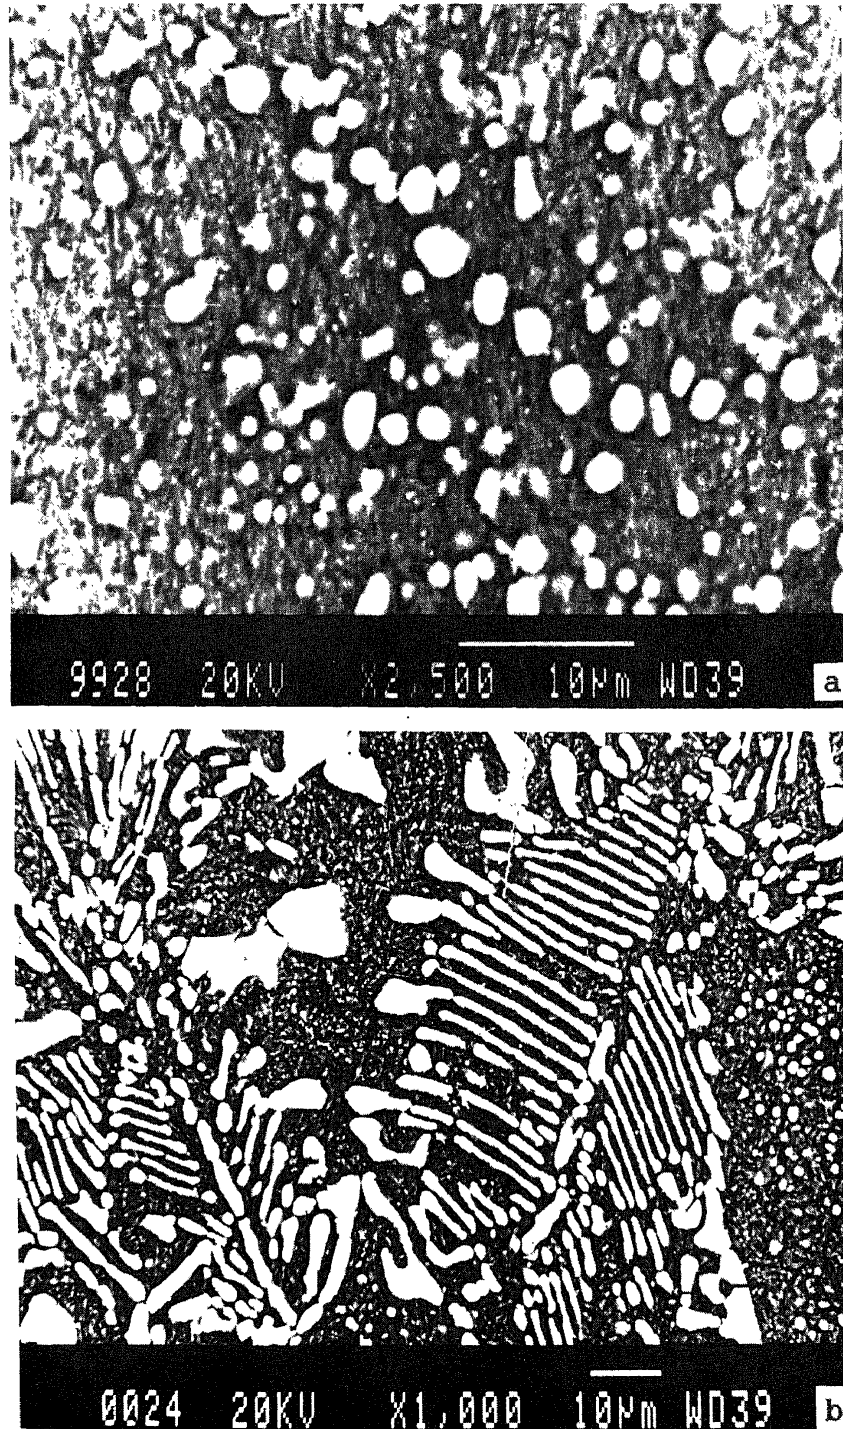
A piece of the failed die was prepared and examined metallographically to determine the heat-treated structure of the steel (figure 2a) which contained a bimodal distribution of spheroidal carbides of size 0.5–1 μm and 2–3 μm . In some locations there also existed some amount of lamellar carbide, fairly coarse in size (figure 2b). However, it was confirmed that this situation did not alter the fracture behaviour of the steel.

Figure 2. Microstructure of the die container steel showing a. a bimodal distribution of spheroidal carbides and b. lamellar carbide.

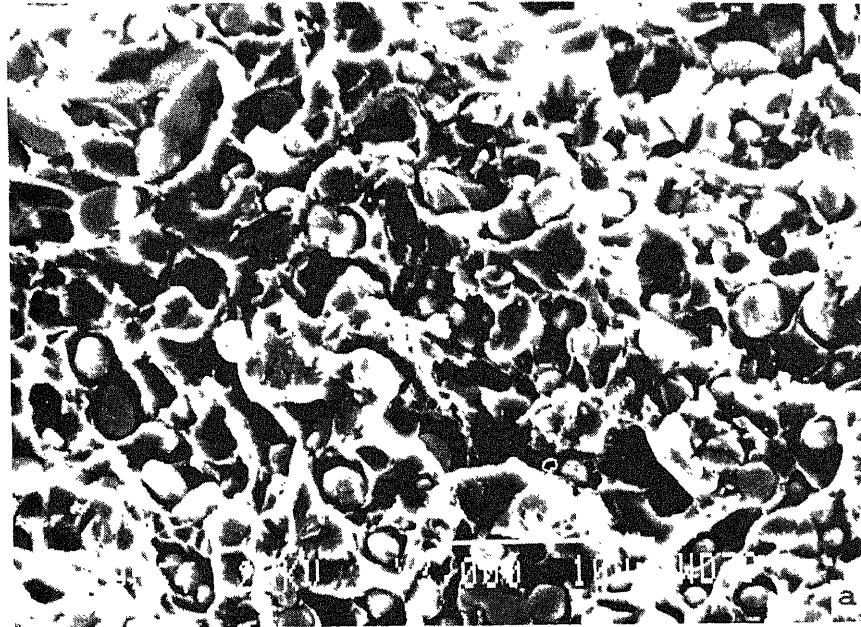
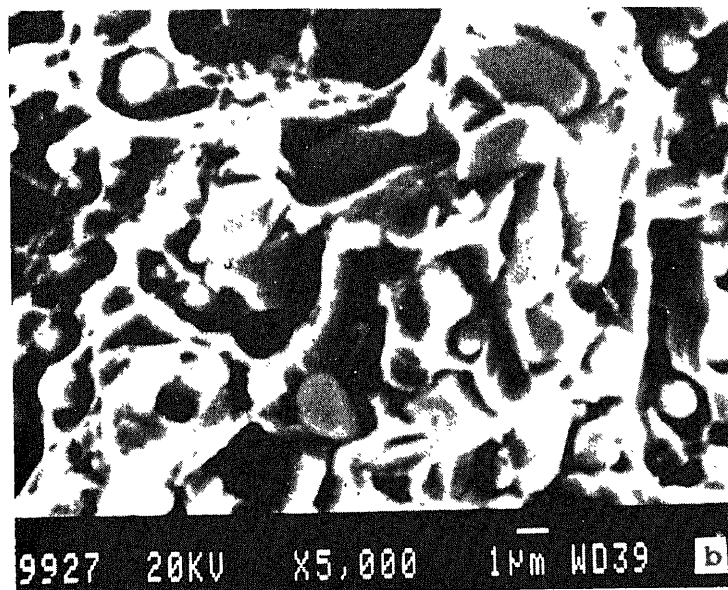
Representative areas of the fracture were examined with SEM to determine the fracture behaviour. Fracture always appeared to be ductile (figures 3a and b), and indicated a predominant carbide/matrix decohesion as the mechanism of fracture for both spheroidal carbide and the lamellar carbide. The fracture morphology near the inner edge of the die that was in contact with the Al–Li alloy extrudant was completely different (figures 4a and b). Areas close to the inner edge of the die revealed the presence of surface irregularities in an otherwise well-polished surface. There occurred visible areas of interaction, about 90–100 μm deep. These are considered to be the regions in which Li reacted with the steel to generate nucleation of the failure. In several locations adjacent to the interaction zone the stronger carbide exhibited fracture by cleavage (figure 4a). Figure 5 exhibits the presence of a deep crack separating the regions of failure that are ductile in nature on the one side and what appears to be cleavage on the other side.

Figure 3. a and b. Fracture features in the bulk of the die container steel showing carbide/matrix decohesion.

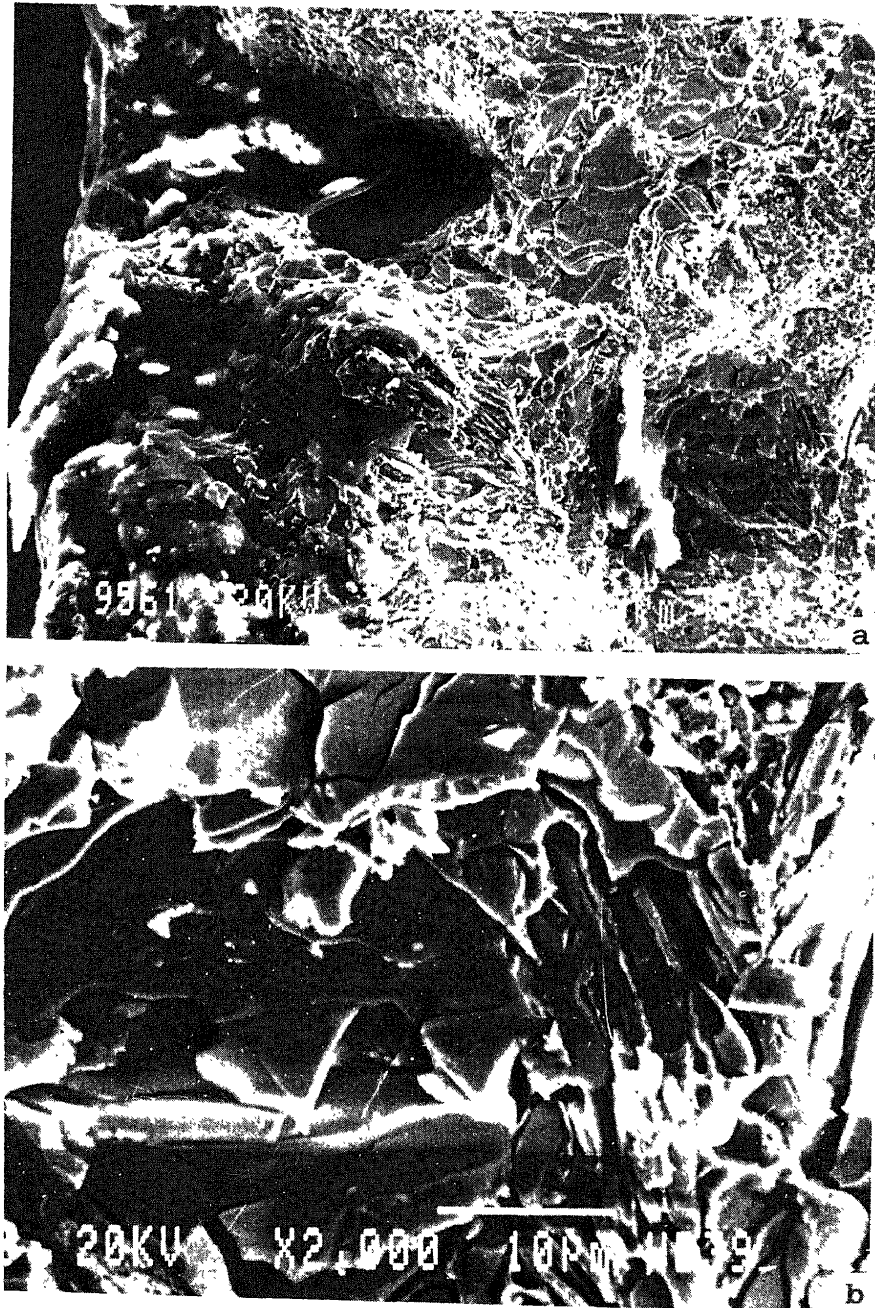
Figure 4. a. SEM fractograph taken close to the edge of the failed container showing interaction zone and fracture by carbide cleavage and b. more clearly seen at higher magnification.

From figure 4a, it may be observed that fracture by cracking of carbides is only up to a depth of about 150–170 μm . It is interesting to note that this depth matches approximately well with the depth of Li penetration in 316 steel that has been observed (about 140 μm) by Wu *et al* (1990). Also it is observed that while the fracture mechanism in general in the steel is by carbide/matrix interface decohesion (figures 3a and b), close to the surface the decohesion does not appear to be predominant. On the other hand a number of larger carbide particles have shown tendency to fracture by cracking. This type of fracture is considered to occur due to the interaction of Li with carbides.

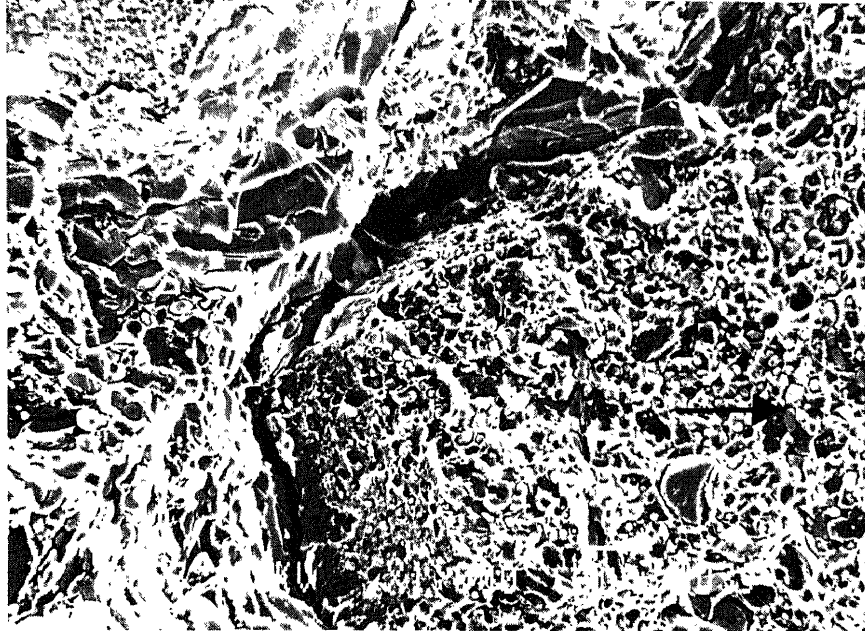
Figure 5. A deep crack near the surface of the failed container showing carbide/matrix decohesion on one side (away from the interaction zone, indicated by the arrow) and carbide cleavage on the other (towards the interaction zone).

Close to bottom region of the die container (figure 5), a crack about 3–5 μm wide appears as though formed by a penetrating fluid. This crack also separates regions of ductile failure on the right (interior) and cracked carbides on the left (closer to the surface). This was an abnormal observation not generally found in heat-treated H11 steel. It is therefore thought that this kind of failure may be due to interaction with Li. Further experiments are in progress to determine the exact nature of the effect of Li on high strength steels.

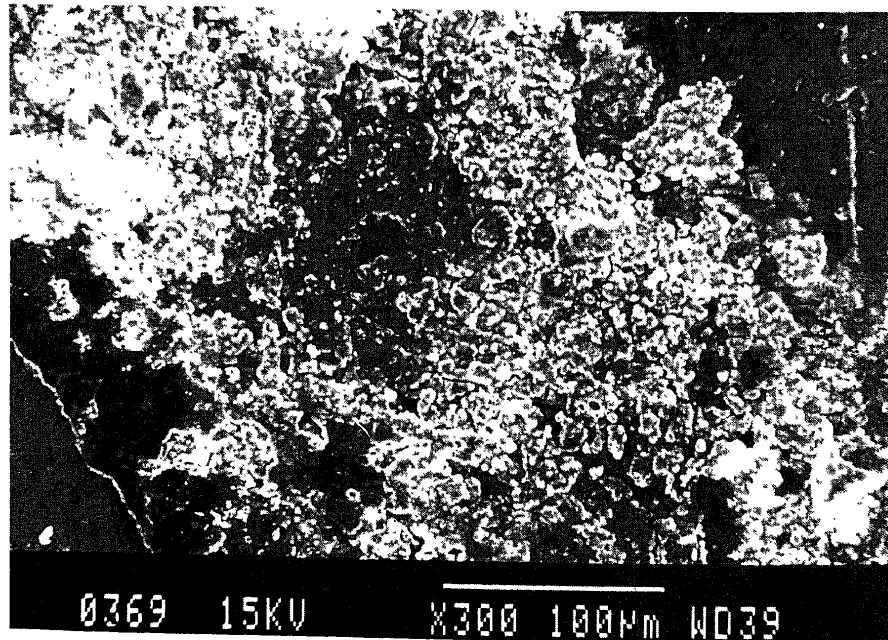
In order to get confirmatory evidence, a pair of well-polished carbon steel plates were interlined with a thin sheet of 8090 Al–Li alloy and clamped together using a C-clamp. This composite was then soaked at a temperature of 673 K (same as the temperature of extrusion) for 4 h in a vertical tube furnace. After soaking, the clamp was removed, and the plates were attempted to be separated. In a number of cases the Al–Li alloy plate and the steel plates got stuck to each other and required considerable force to separate. On being separated, a certain amount of material transfer on to the steel surface was observed. SEM observations revealed that the steel surface was attacked and severely pitted (figure 6). A transverse section in the attacked region of the steel did not show any variation in the microstructure. However microhardness measurements (figure 7) indicated a small decrease in hardness to a depth of about 150 μm . This obviously should be due to the attack of Li on the carbides.

Figure 6. SEM picture of the steel surface after diffusion anneal of Al–Li alloy/steel couple showing deep pitting.

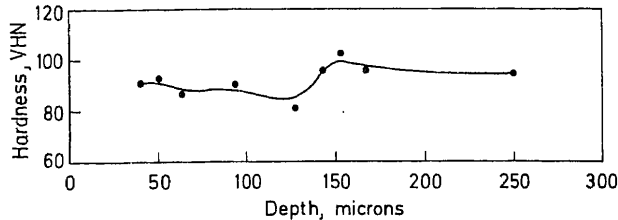
Figure 7. Microhardness profile of the transverse section of the steel after heat treatment in combination with Al-Li alloy.
