EXPERIENCE IN IN-SITU REPAIR WELDING OF STEAM TURBINE SHROUDS AND BLADES

S.K. Albert, V. Ramasubbu, C.R. Das, A.K. Bhaduri, S.K. Ray and Baldev Raj
Metallurgy and Materials Group, Indira Gandhi Centre for Atomic Research,
Kalpakkam 603 102, India

Abstract

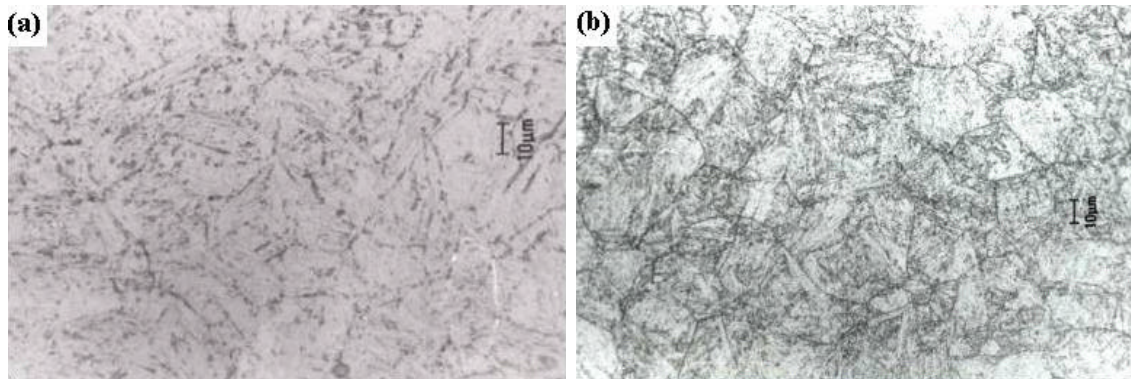
As mentioned earlier, the repair welding procedure was qualified using AISI 410 SS pipe material and not on actual shroud or blade material. Hence, microstructural examinations and hardness measurements on the actual shroud welds in the as-welded and PWHT conditions could not be carried out during the procedure development stage. Further, during actual repair welding, it was not possible to measure the hardness of the HAZ of the repair welds. However, confidence with respect to success of the repair welding procedure would be significantly better with the availability of HAZ hardness data in the as-welded and PWHT conditions on the actual shroud/blade material. During one of the repair welding operations, an actual shroud piece was made available for carrying out welding and subsequent laboratory investigations. A weld pad was prepared using this shroud piece employing the same welding parameters that were employed for the actual repair. One part of this welded test-piece was retained in the as-welded condition, while the other part was subjected to PWHT similar to that employed during the actual repair welding, and microstructural examination and hardness measurement were carried out on these two test-pieces. Figure 8 shows the microstructures of the HAZ in the as-welded and PWHT conditions. The microstructure of the HAZ in the as-welded condition (Fig. 8a) consists of fully untempered martensite, while that after PWHT (Fig. 8b) shows substantial tempering of the martensite with its microstructure being similar to that observed in the in-situ metallographs of the actual repair-welded shroud (Fig. 6). The

Fig. 8: Microstructures of the HAZ in the actual shroud material examined in the laboratory: (a) in as-welded condition and (b) after 873 K/1 h PWHT

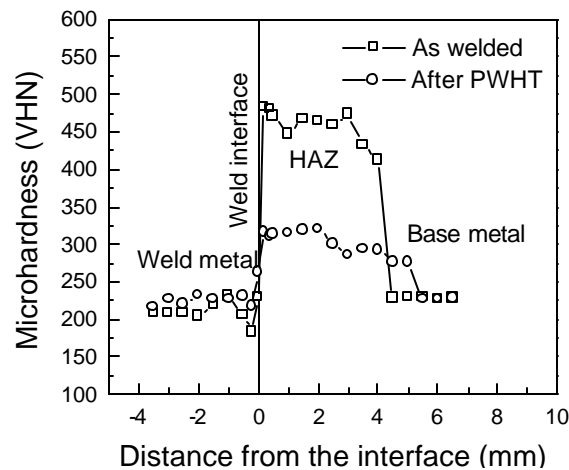
microhardness profile across the weld/base metal interface before and after PWHT (Fig. 9) shows that the hardness of the HAZ decreases from above 450 VHN in the as-welded condition to about 300 VHN after the 873 K/1 h PWHT, thereby confirming the adequacy of the PWHT carried out on the repair-welded shroud.

Fig. 9: Microhardness profile across the weld/base metal interface in the actual shroud material: (a) in as-welded condition and (b) after 873 K/1 h PWHT
