## Failure Analysis towards Reliable Performance of Aero-Engines

T. Jayakumar, N.G. Muralidharan, N. Raghu, K.V. Kasiviswanathan and Baldev Raj  
*Indira Gandhi Centre for Atomic Research, Kalpakkam - 603 102.*

### 2.1 Turbine Blades Failure due to over Temperature Exposure

## 2.2 Turbine Blades Failure due to Hot Corrosion

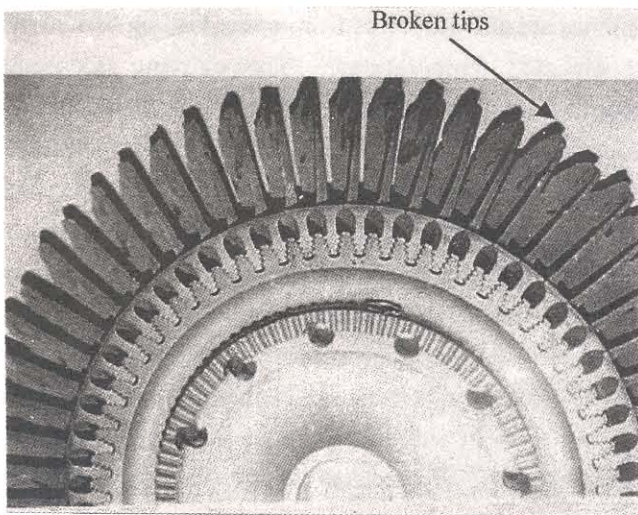
chamber was also provided with a number of thermocouples to measure the compressor inlet gas temperature. At the time of failure, abnormal sound was heard followed by the engine failure, and the speed of the compressor came down to 2 per cent and the gas temperature also reduced drastically. Strip out examination revealed total failure of the shroud tips of all the 61 blades in the first stage and 71 blades in the second stage (Fig. 1). In addition to this, partial melting of the thermocouple heads fitted to the first nozzle diaphragm assembly was also noticed. The casing appeared bluish, and the blade debris was found strewn throughout the casing. The failed shroud tips were found blunt.

Figure 1. Failed turbine blades

Temperature monitoring device is to be augmented to detect excess heating of the aero-engine beyond the acceptable limits. Better quality control of the protective coatings during overhauls is recommended to avoid over temperature exposure leading to microstructural changes during service.

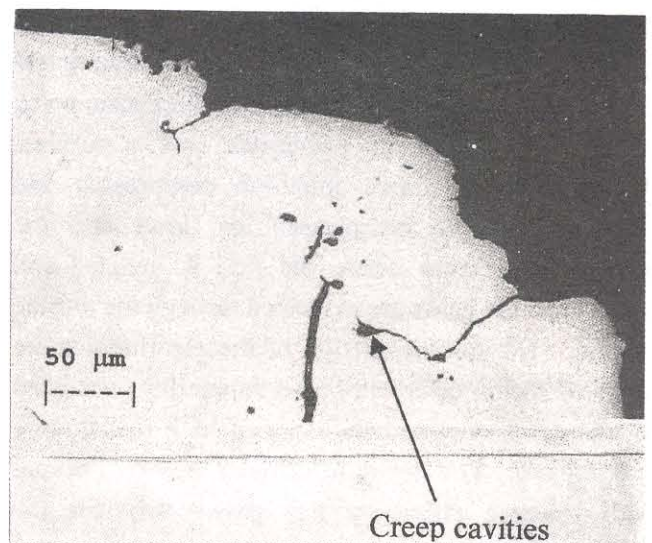
Metallographic examination were conducted on the failed blades, unused blades and partially-used (500 hr blades). Examination of the failed blades revealed a lot of creep cavities as shown in Fig. 2. The protective aluminide coating was also found to have spalled and dislodged from the surface as shown in Fig. 3. The etched surface revealed grain coarsening; absence of gamma prime precipitates in the gamma matrix and grain boundary carbides as shown in Fig. 4. Cracking of the grain boundary carbides was also seen on a number of places. The microstructure of the

Figure 2. Polished first stage blade showing creep damage

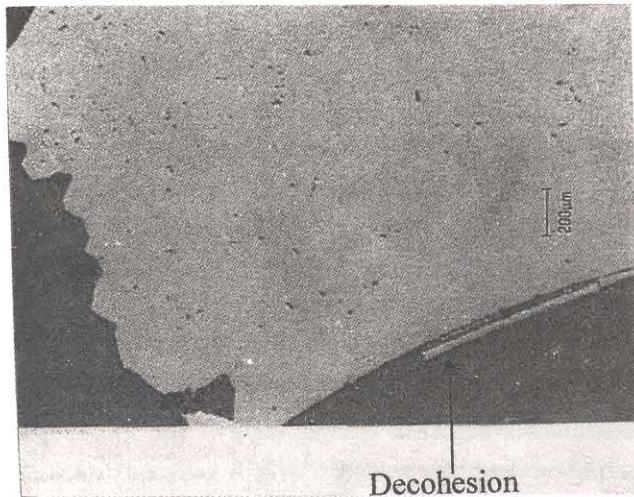
Figure 3. Photomicrograph showing decohesion of protective coating.

The spalling/decohesion of the aluminide coating observed could have led to the microstructural changes

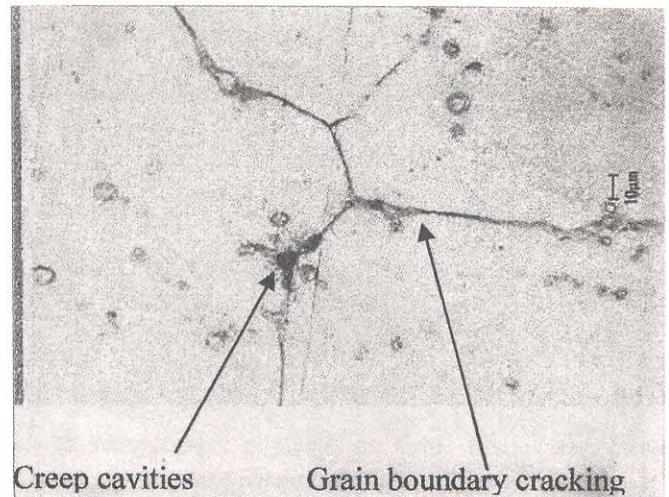
The total absence of the strengthening precipitates in the matrix of blades, presence of creep cavities on the grain boundaries, excessive grain growth and cracking of grain boundary carbides confirm<sup>1,2</sup> over temperature exposure to approximately 1313-1373K. The dislodgement of the protective coating and melt down of the thermocouples confirm that the temperature was not within the normal operating range. Creep occurs readily at an elevated temperature due to reduction in strength by the dissolution of gamma prime precipitates and also due to grain coarsening. As a result of overageing, there was appreciable grain growth and segregation of carbides at grain boundaries.

Figure 4. Photomicrograph showing creep cavities and cracking of grain boundary carbides.

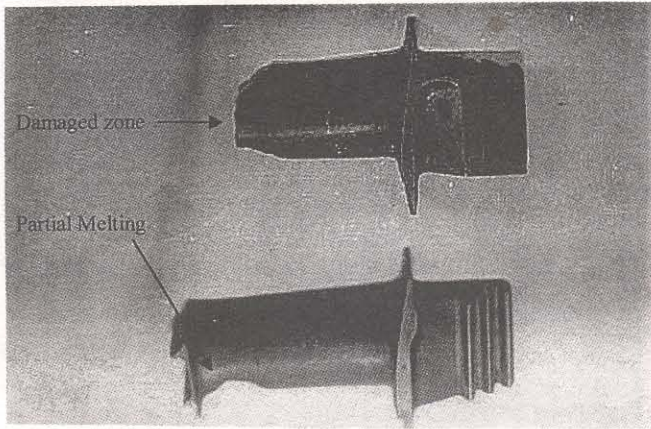
Figure 5. Failed turbin-blade

Visual examination of the failed turbine blades revealed that the failure was adjacent to the shroud tip area (Fig. 5). The fractured surface was found to be heavily oxidised with no indication of plastic deformation. The external surface of the blade was free from any deterioration like scaling and pitting. Metallographic examination revealed grain boundary spikes and disruption of the protective surface coating as shown in Fig. 6. These areas were also seen to have matrix-depleted zones, below the protective coating on the blade surface. Creep voids and cracking were observed at many locations and the protective coating had also cracked at many locations.

Limitation of sulphur and alkali contents in the fuel through careful control of specification is recommended. Stringent specifications for the quality control of protective surface coating during manufacture

and subsequent inspection overhauls can significantly reduce the failure incidents.

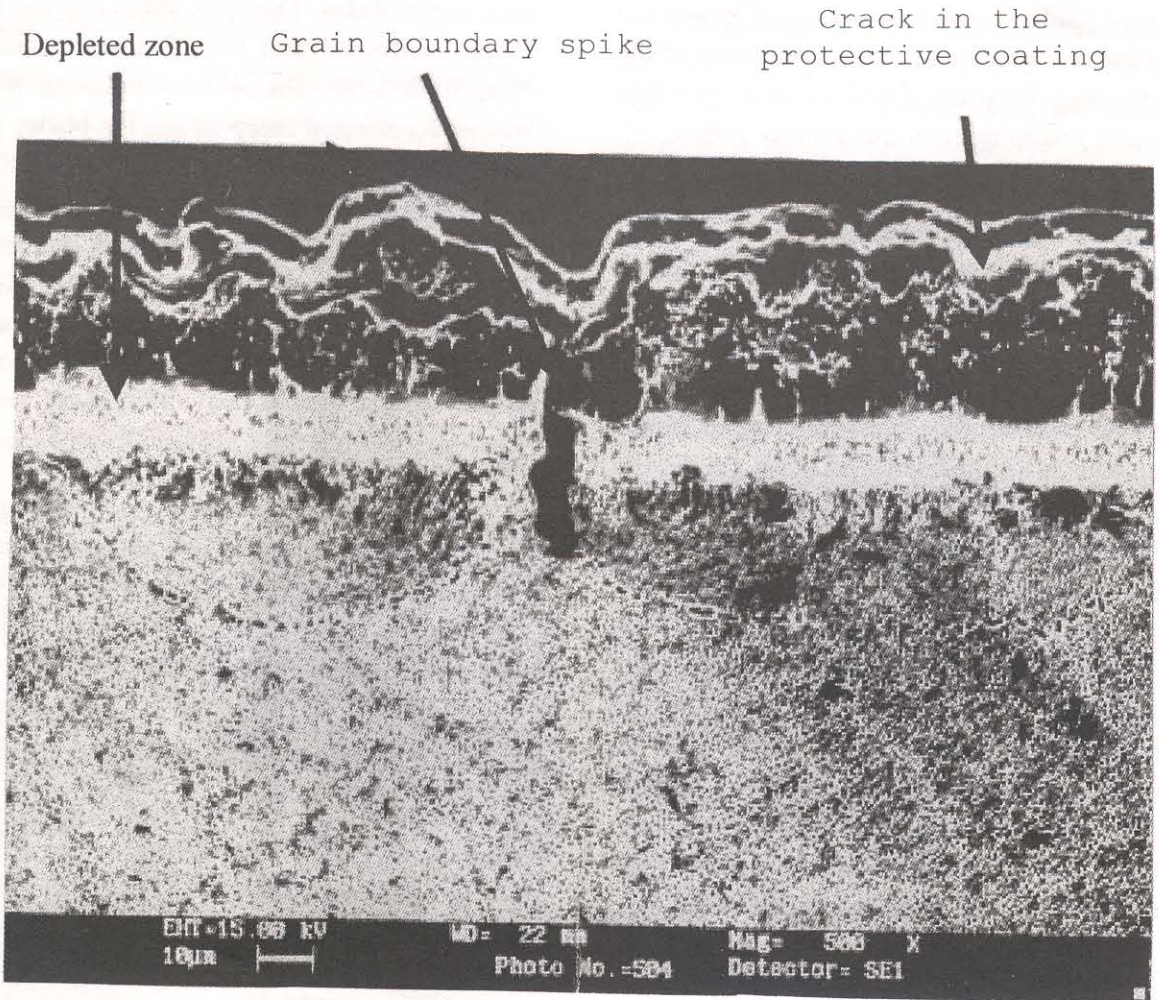
Figure 6. SEM photomicrograph showing hot corrosion damage

Metallographic observations revealed that the failed turbine blade had undergone non-layer form of hot corrosion damage due to combined action of oxidation and sulphidation<sup>3</sup>. The high temperature form of hot corrosion is attributed to the action of condensed salts deposits formed by the combustion between the sulphur in the fuel and the sodium present either in the fuel or in the ingested air. Presence of grain boundary spikes and matrix-depleted zones along with cracks in the coating are typical indications for non-layer form of hot corrosion.
