EXPERIENCE IN IN-SITU REPAIR WELDING OF STEAM TURBINE SHROUDS AND BLADES

S.K. Albert, V. Ramasubbu, C.R. Das, A.K. Bhaduri, S.K. Ray and Baldev Raj
Metallurgy and Materials Group, Indira Gandhi Centre for Atomic Research,
Kalpakkam 603 102, India

Abstract

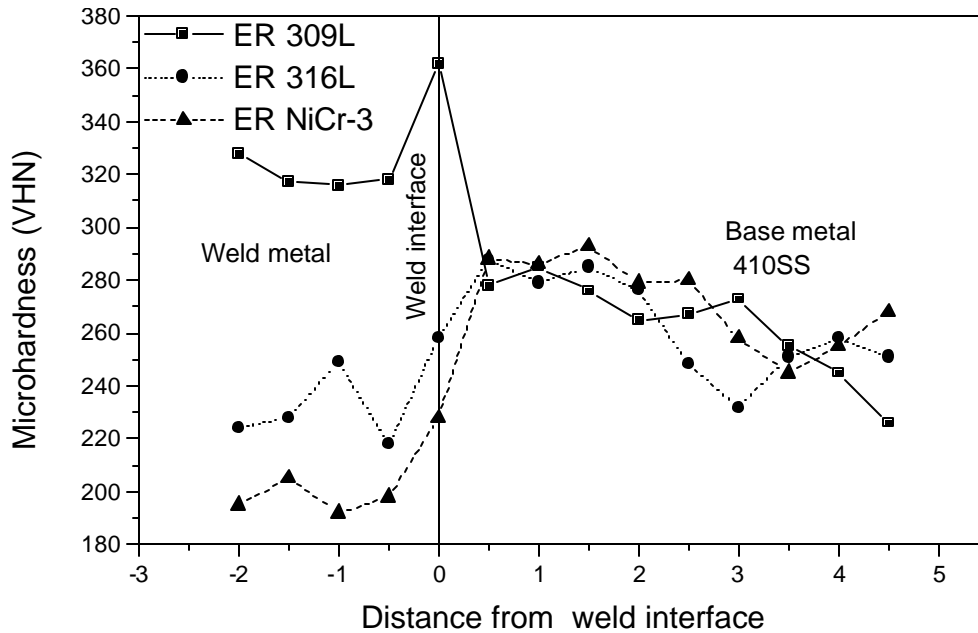
Fig. 2: Hardness profile after 873K/1h PWHT across the fusion line for welds prepared using three different welding consumables during procedure development.

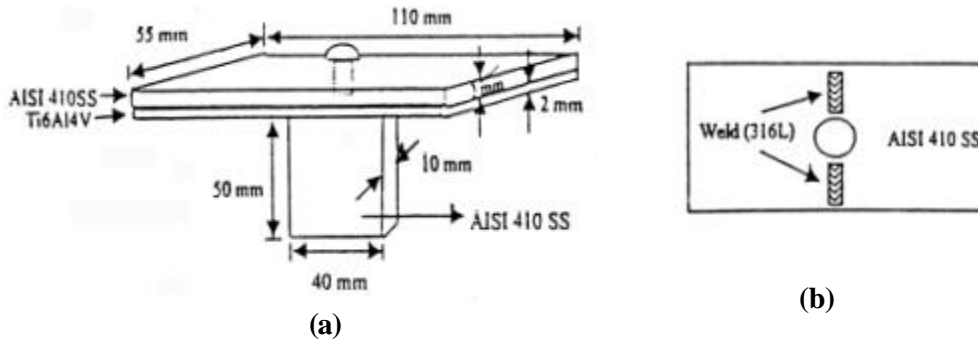
demonstrate that during repair welding, no inadvertent welding of the shroud piece with either the blade or the understrap takes place. For this purpose, a mock up assembly that simulates the presence of understrap, blade and tenon hole in the shroud, as shown in Fig. 3(a), was prepared. Welding was carried out using the optimised parameters on top of this assembly as shown in Fig. 3(b) and it was possible to successfully demonstrate that repair welding can be carried out by a skilled welder without causing any damage to both the understrap and blade by carefully controlling the welding parameters.

Fig. 3: Mock-up for welding of the shroud at a location where blade and understrap are riveted: (a) mock-up assembly; and (b) top view of the assembly after welding.
